Test Report

Report No. A2190124736101R1

Sample Name F2E225-230-DVP

No.	Test Item
1	IP5X
2	IPX5

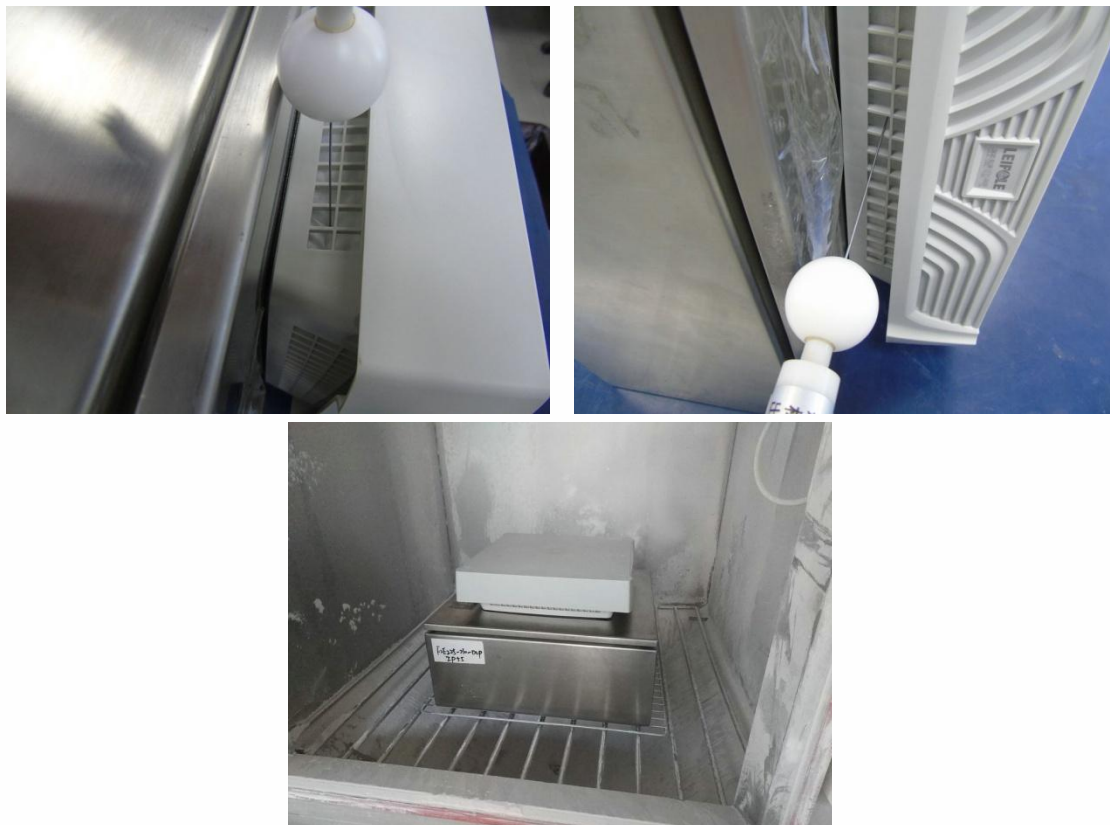
Set-up Photos

- a) The test prober of 1mm diameter is pushed against any opening of the sample with force of 1 N;
- b) The talcum powder to be used is 2kg/m³ of the test chamber volume
- c) Test duration: 8 hours

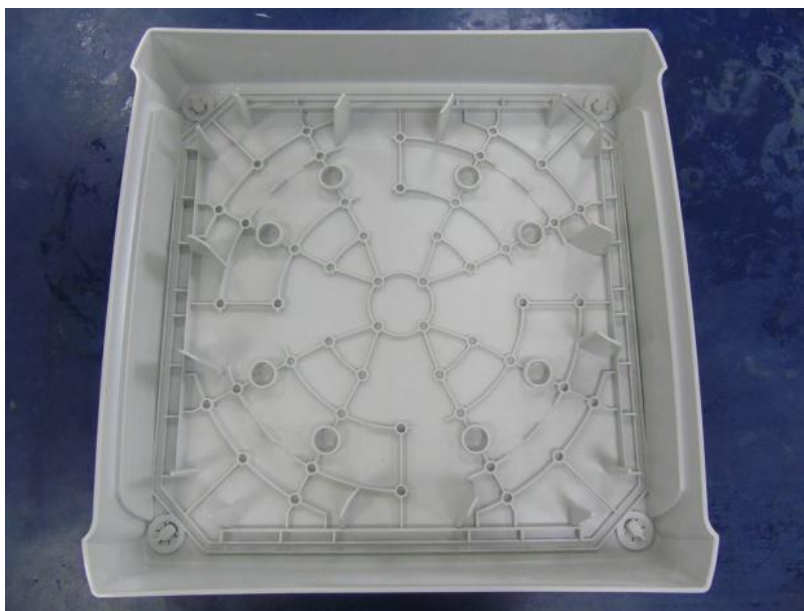
Sample No.	Test Result(s)
A2190124736101001	Visual inspection, test probe cannot into the sample. No obvious dust was observed in the sample after test. The fan of the sample can run normally. IP5X test was passed.

Sample Photo(s) after the test

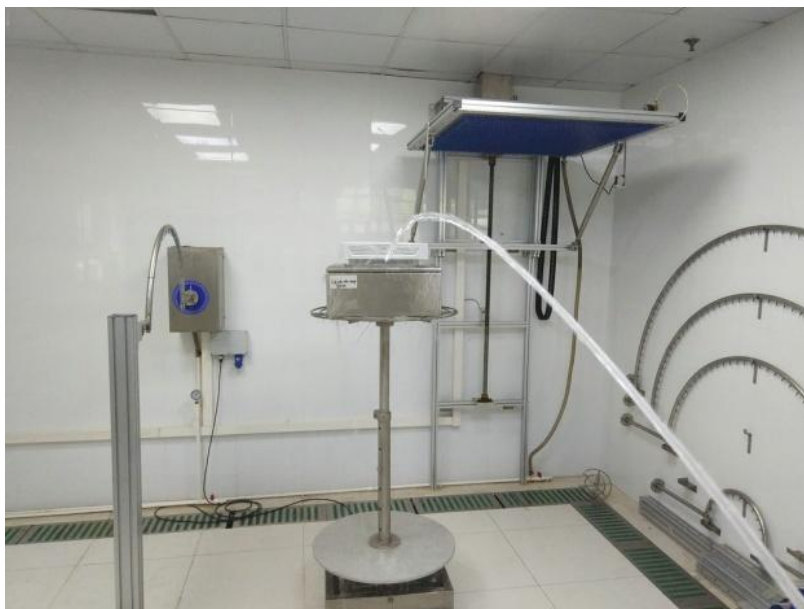
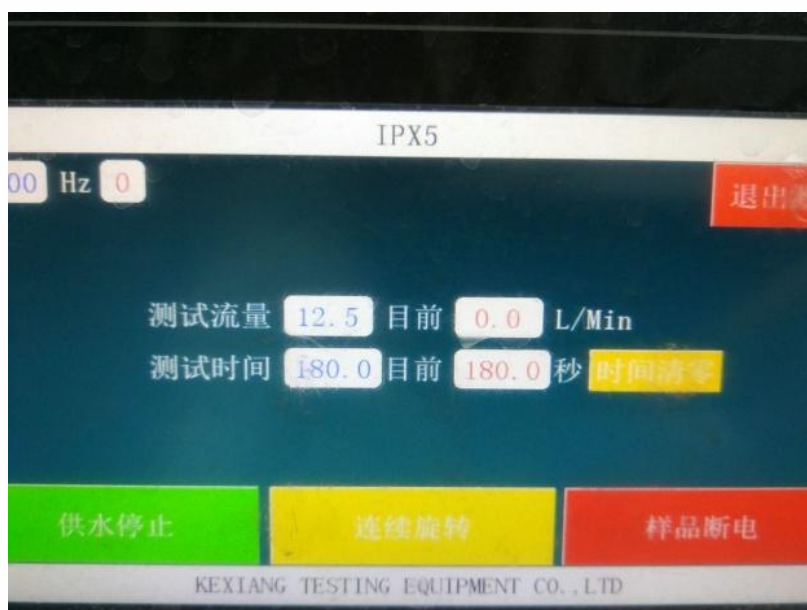
Set-up Photos

- a) Water flow rate: 12.5L/min
- b) Distance from sample surface to nozzle: 2.5~3m
- c) Diameter of the nozzle: 6.3mm
- d) The rotation speed of the turntable: 1r/min
- e) Test duration: 3 min

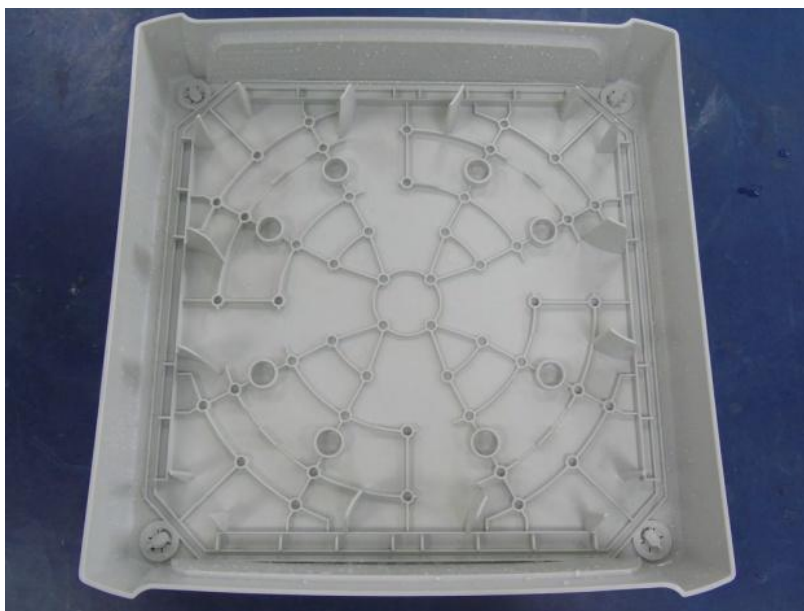
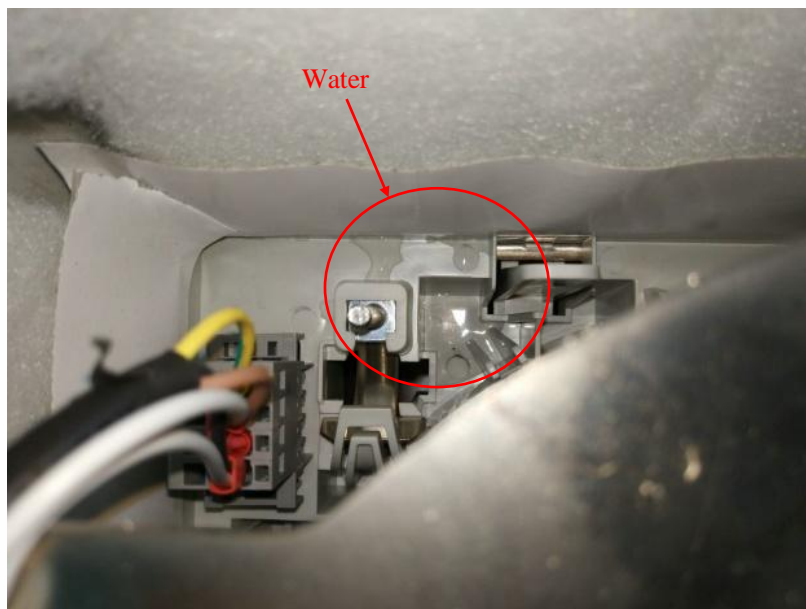
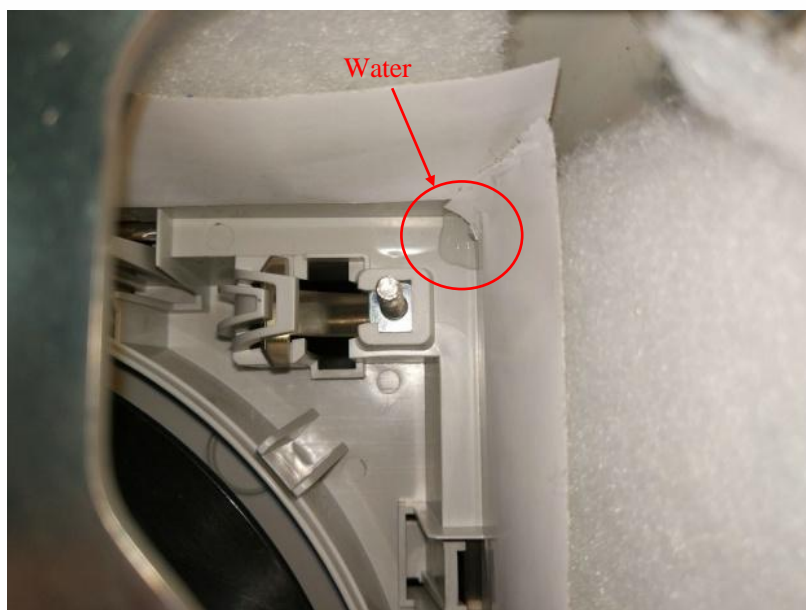
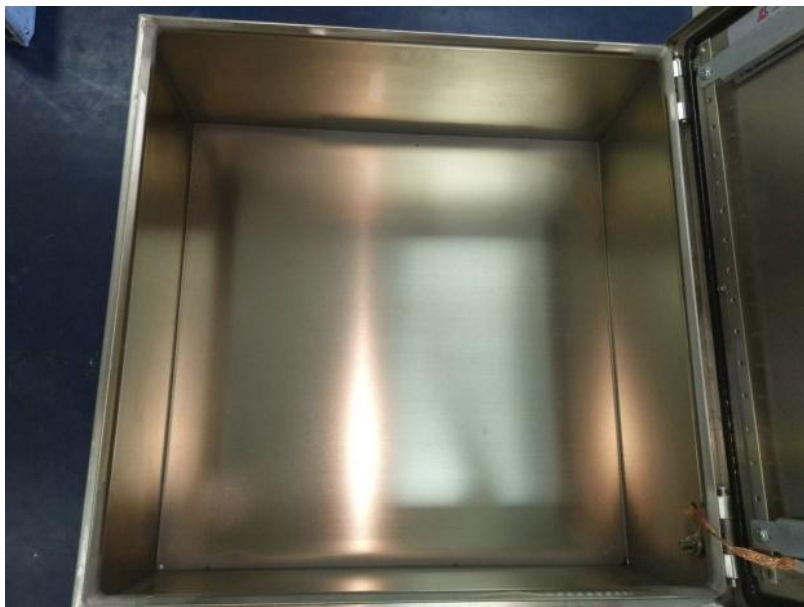
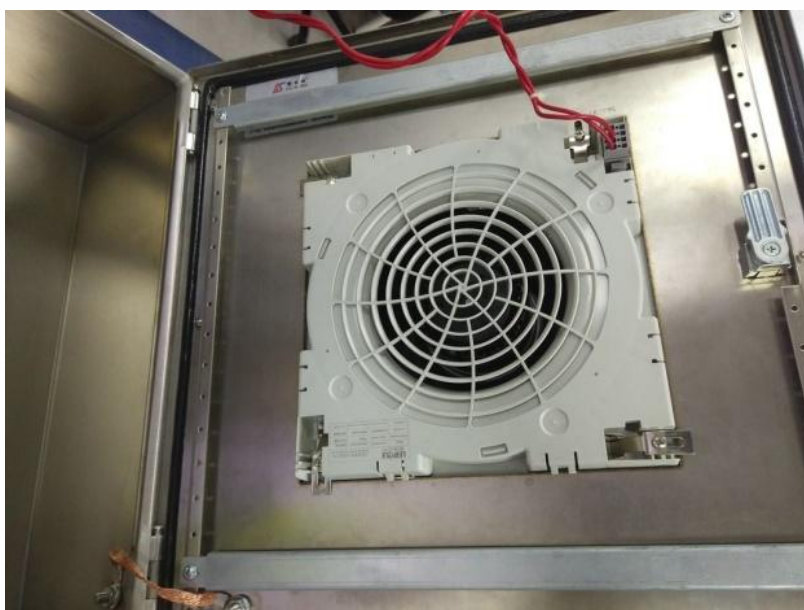
Sample No.	Test Result(s)
A2190124736101001	Water was observed in the sample by visual inspection after test, But water does not touch live parts of the sample. The fan of the sample can run normally. IPX5 test was passed.

Sample Photo(s) after the test
